The Keadby 3 Low Carbon Gas Power Station Project

Preliminary Environmental Information (PEI) Report Volume II - Appendix 11F: Riparian Mammal Survey Report

Applicant: SSE Generation Limited

Date: November 2020

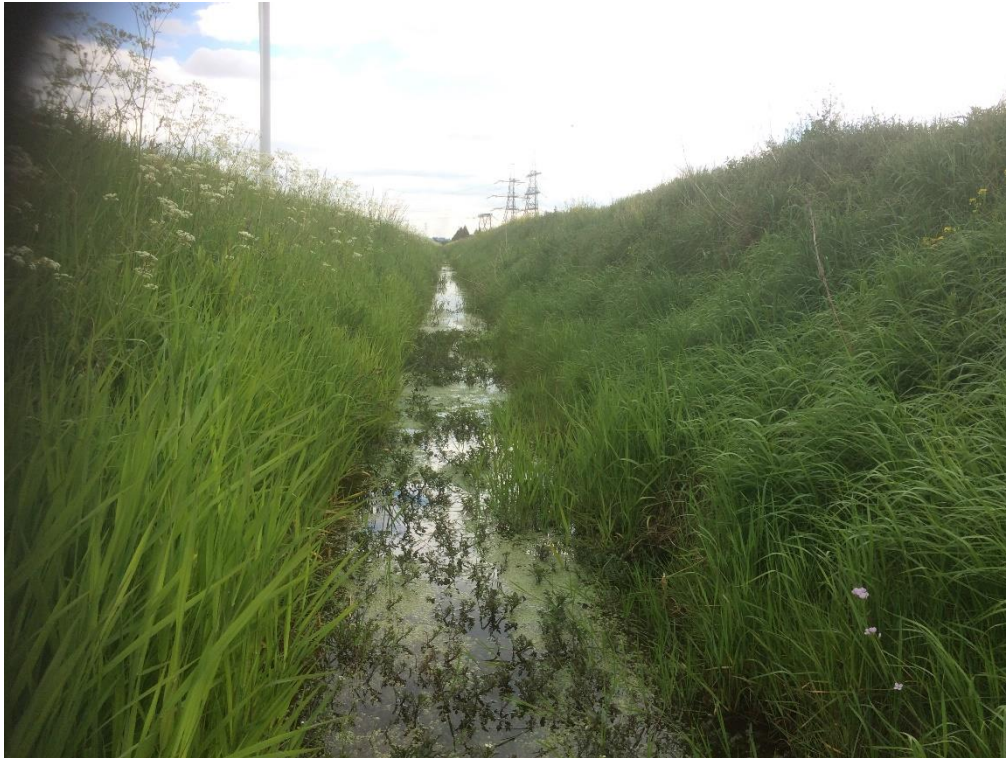
Photograph 1 - Drain 1 (Keadby Common Drain)

- 4.2.3 This drain, located on the northern boundary of Keadby Common, has a channel width of between 1 and 2m and variable water depths that are less than 0.6m throughout. The banks are of earth, so are suitable for water vole burrowing. The drain and its banks support extensive stands of suitable foodplants, including emergent grasses and

sedges (**Annex B**, Photograph 1). Bankside trees are absent and there is no shading of the channel.

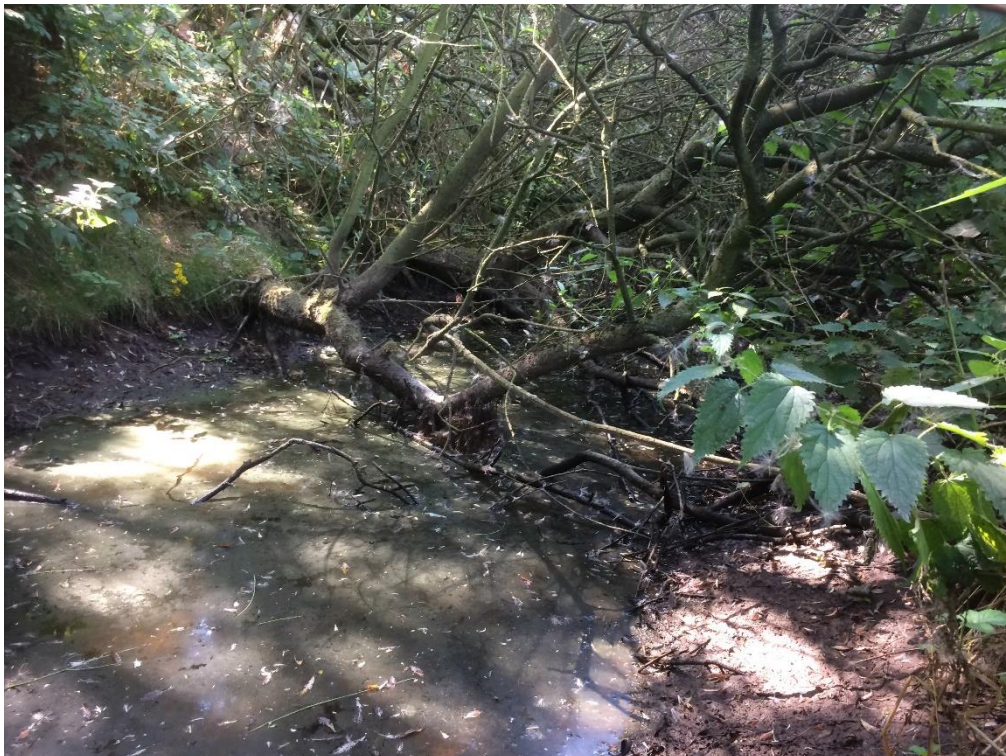
Photograph 2 - Drain 2, western section

- 4.2.8 The western section of the drain is approximately 2-3m wide with water depths of between 0.2 and 0.5m (**Annex B**, Photograph 2). This section of drain has earth banks. The southern bank is dominated by dense willow scrub, which overhangs the drain and casts heavy shade over approximately 70% of the channel, reducing the cover of wetland plant species and by so doing making the habitat sub-optimal for water vole. The northern bank supports unmanaged rank, semi-improved grassland. In-channel and bank vegetation suitable to sustain water voles is restricted to the 30% of the channel where shading is reduced.

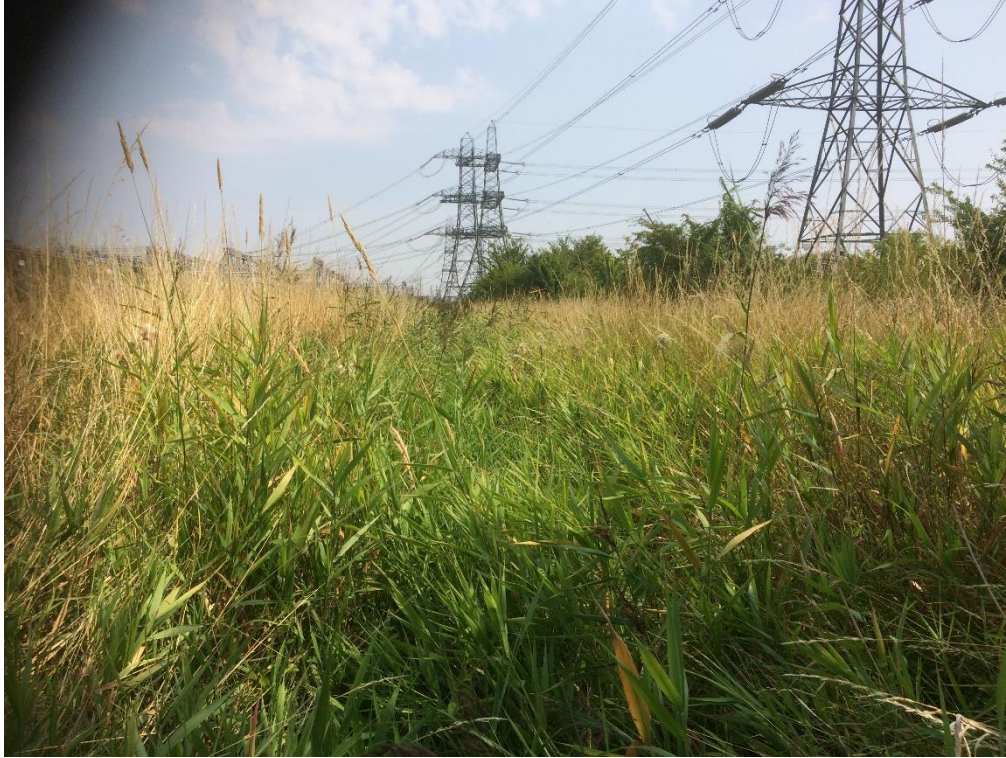
Photograph 3 - Drain 2, eastern section

- 4.2.9 The eastern section of the drain is narrower (approximately 1-2m wide) and is dominated by reeds (**Annex B**, Photograph 3), so contains extensive suitable food plants for water vole. The earth banks support rank semi-improved grassland. This whole section is dry and is judged to only support water during the wetter months of the year.

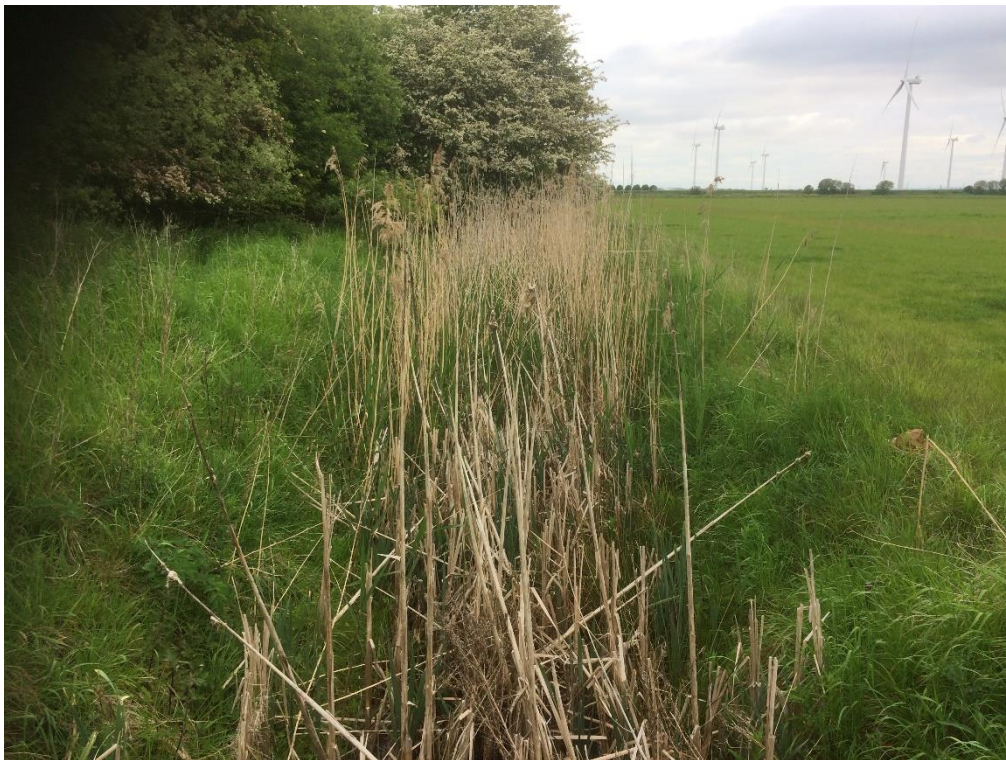
Photograph 4 - Drain 3

- 4.2.12 This drain, located on western boundary of Keadby Common, has a channel width of 1-2m. During the first survey, the water depth was between 0.2 and 0.5m but the whole length was dry during the return survey. The drain is dominated by reeds along its entire length (**Annex B**, Photograph 4), so contains suitable food plants for water vole.
- 4.2.13 The drain has earth banks approximately 0.5 - 1m in height, one of which supports dense scrub, shading approximately 20% of the channel. The other supports unmanaged, rank semi-improved grassland.
- 4.2.14 There was no evidence of water vole associated with this drain. Given that the drain is regularly subject to drying, it is considered sub-optimal for water vole.

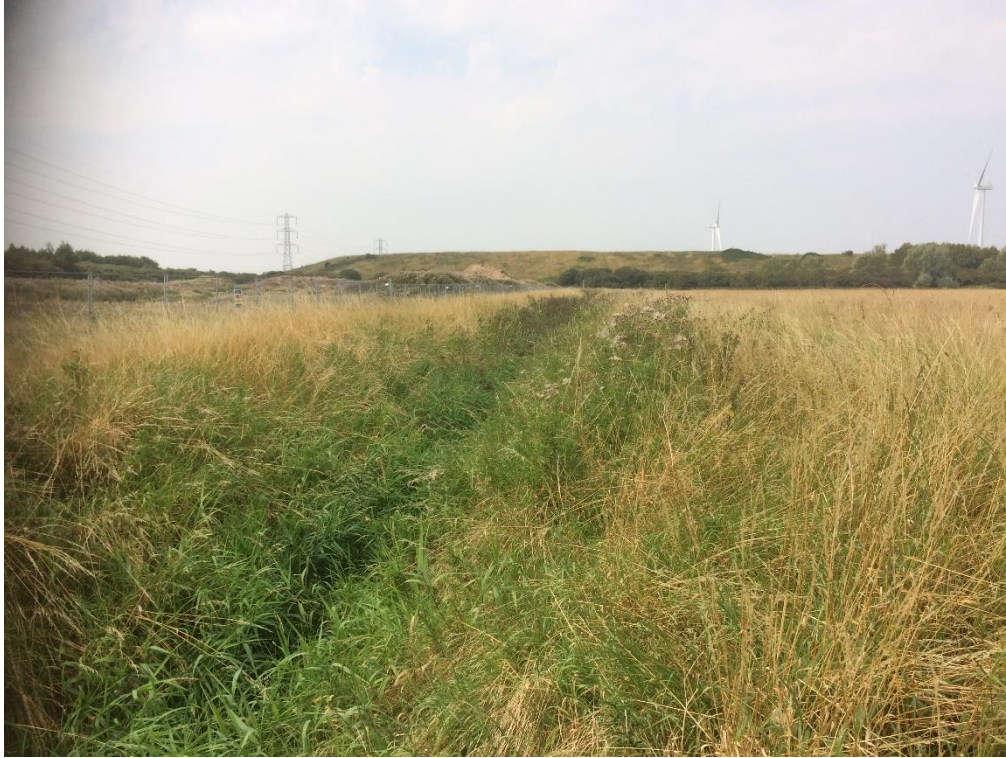
Photograph 5 – Drain 4

- 4.2.15 This drain bisects Keadby Common. The channel width is approximately 1m; the drain, has earth banks, and during the initial survey the water depth was very shallow (0.1m) and the channel was locally dry. By the second survey, the whole drain was dry. The drain is dominated by reeds along its entire length (**Annex B**, Photograph 5) so contains suitable food resources for water vole. Bankside trees are absent and there is no shading of the channel.
- 4.2.16 Very limited evidence of water vole was found, which was restricted to a single burrow with some associated feeding remains. This limited field evidence indicates the presence of only a single water vole territory. Given that the drain is subject to regular and prolonged drying, it is considered sub-optimal for water vole.

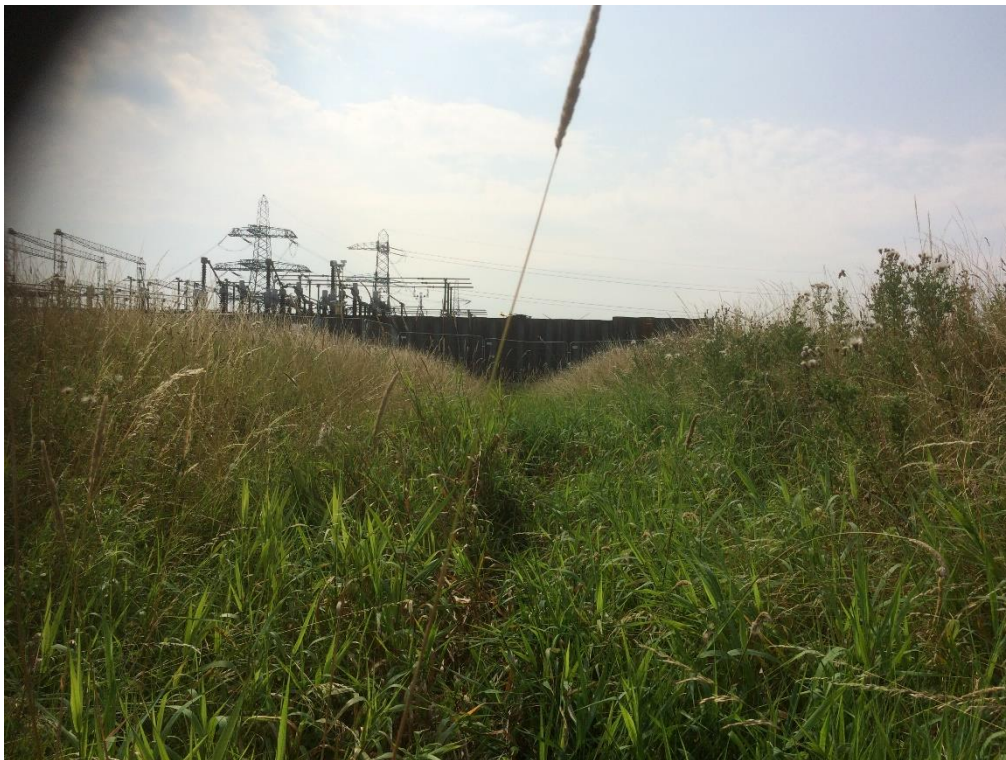
Photograph 6 – Drain 5

- 4.2.17 This drain, on the eastern boundary of Keadby Common has earth banks, a channel width of approximately 1-2m, and was dry during both surveys. The drain is dominated by reeds along its entire length (**Annex B**, Photograph 6). Bankside trees are absent and there is no shading of the channel.
- 4.2.18 There was no evidence of water vole associated with this drain. Given that the drain is regularly subject to drying, it is considered sub-optimal for water vole.

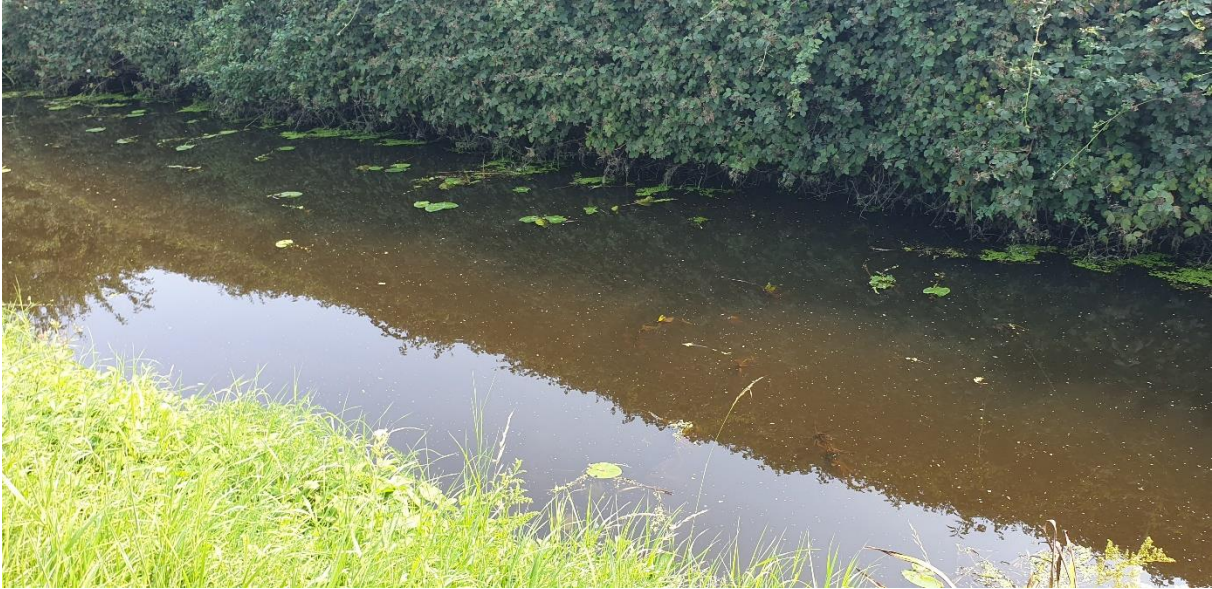
Photograph 7 – North Soak Drain

- 4.2.19 The section of the drain associated with the Proposed Development Site is approximately 10m wide and is greater than 1m in depth. The drain supports occasional small stands of reeds with the open water areas but is otherwise devoid of vegetation suitable to sustain water vole (**Annex B**, Photograph 7).
- 4.2.20 The drain has steep earth banks approximately 1-2m in height. The southern bank between North Soak Drain and the Stainforth and Keadby Canal supports dense bramble scrub, while the other bank supports rank, unmanaged semi-improved grassland with tall ruderals. Bankside trees are absent and there is no shading of the channel.

4.2.21 There was no evidence of water vole associated with this drain. There is minimal food resource for water vole and as such the drain is considered to be sub-optimal for this species. Previous surveys for Keadby 2 Power Station also did not find water vole in this drain.

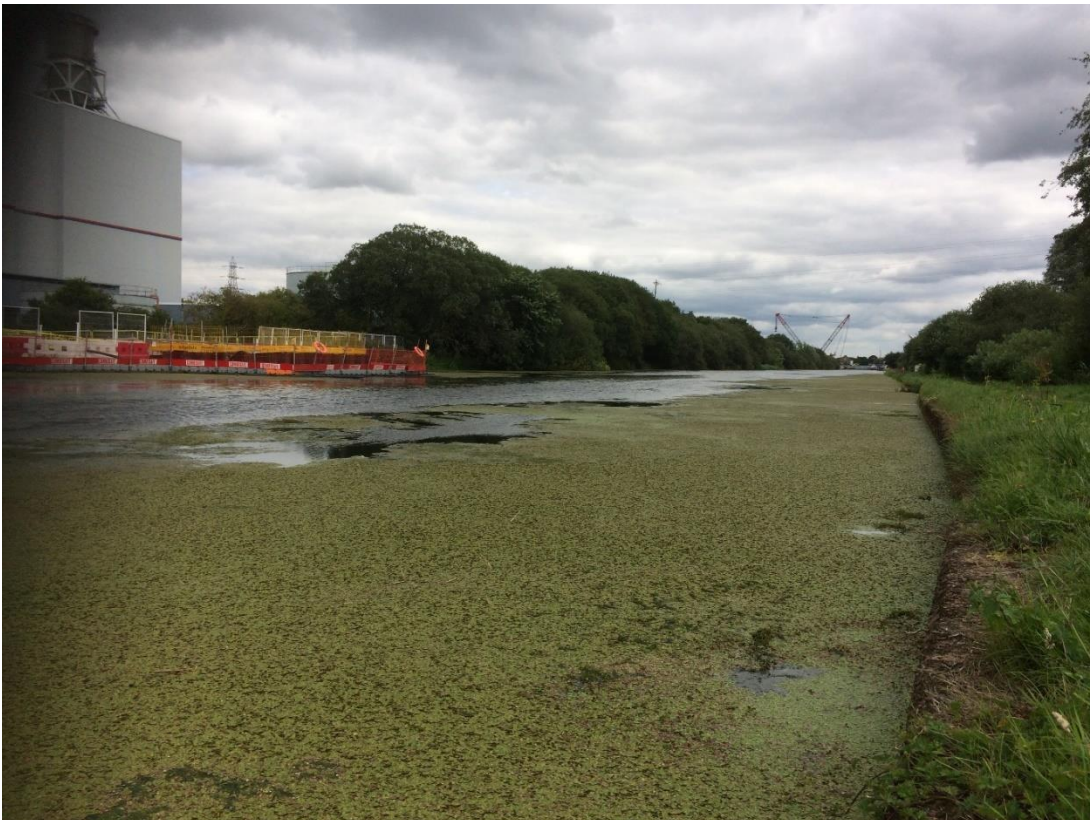
Photograph 8 – Stainforth and Keadby Canal

4.2.22 At the location of the Proposed Development Site, the canal is approximately 40m wide and greater than 1m in depth. The water column is dominated by submerged aquatic plants, with isolated stands of reeds present in the margins (**Annex B**, Photograph 8).

4.2.23 The banks of the canal are vertical and where visible were concrete. Bankside trees and scrub are present on the northern bank of the canal, however given its width shading to the channel is negligible.

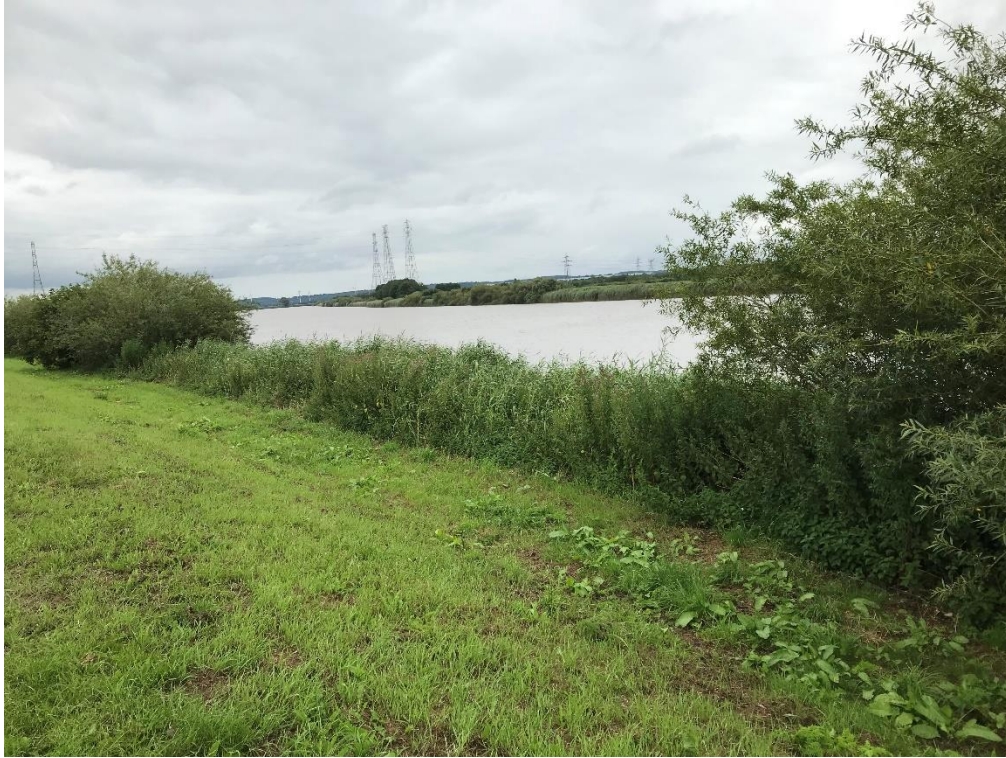
Photograph 9 – River Trent

4.2.25 At the location of the existing water intake and outfall structures, the River Trent is a large (approximately 150m wide) tidal river (**Annex B**, Photograph 9) and is therefore unsuitable for water vole. Water vole is therefore scoped out in relation to the River Trent.

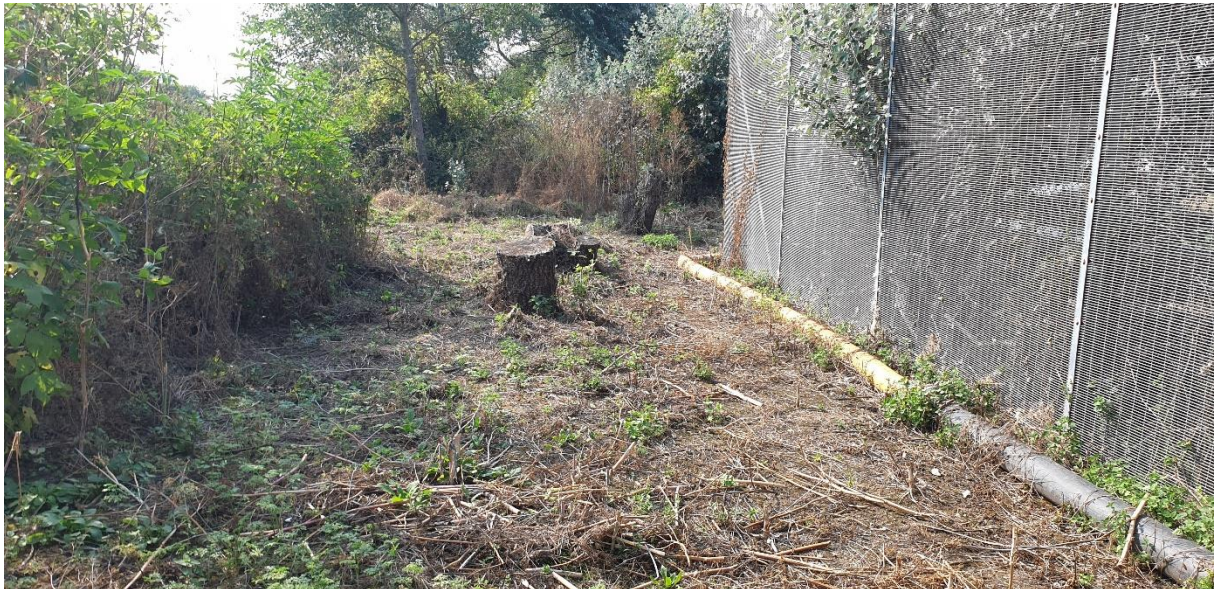
Photograph 10 – Area of woodland cleared for construction of the Keadby 2 Power Station water intake on the Stainforth and Keadby Canal
