The Keadby 3 Low Carbon Gas Power Station Project

PINS Ref: EN010114

Preliminary Environmental Information (PEI) Report Volume II - Appendix 13A: Phase 1 Desk Based Assessment

> Applicant: SSE Generation Limited Date: November 2020

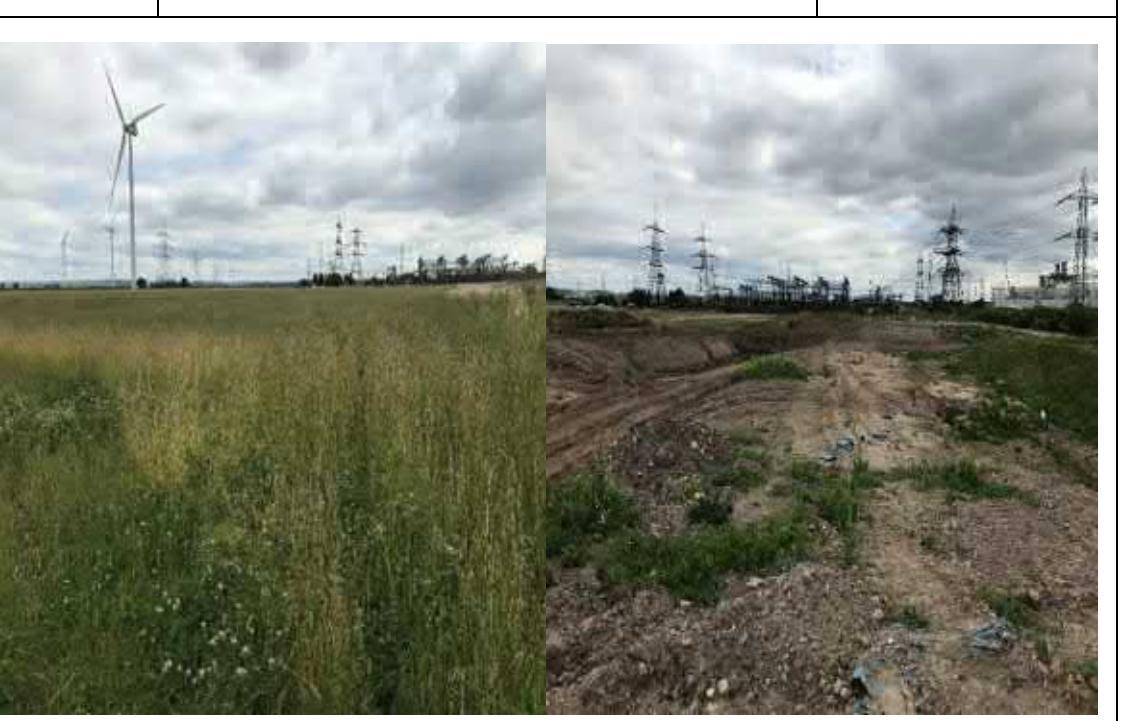
Plate No. 2	Date: 16/07/2020
Description	1:
Extensive ve cover noted	egetative in Keadby
biodiversity some areas	area, with of exposed
ground.

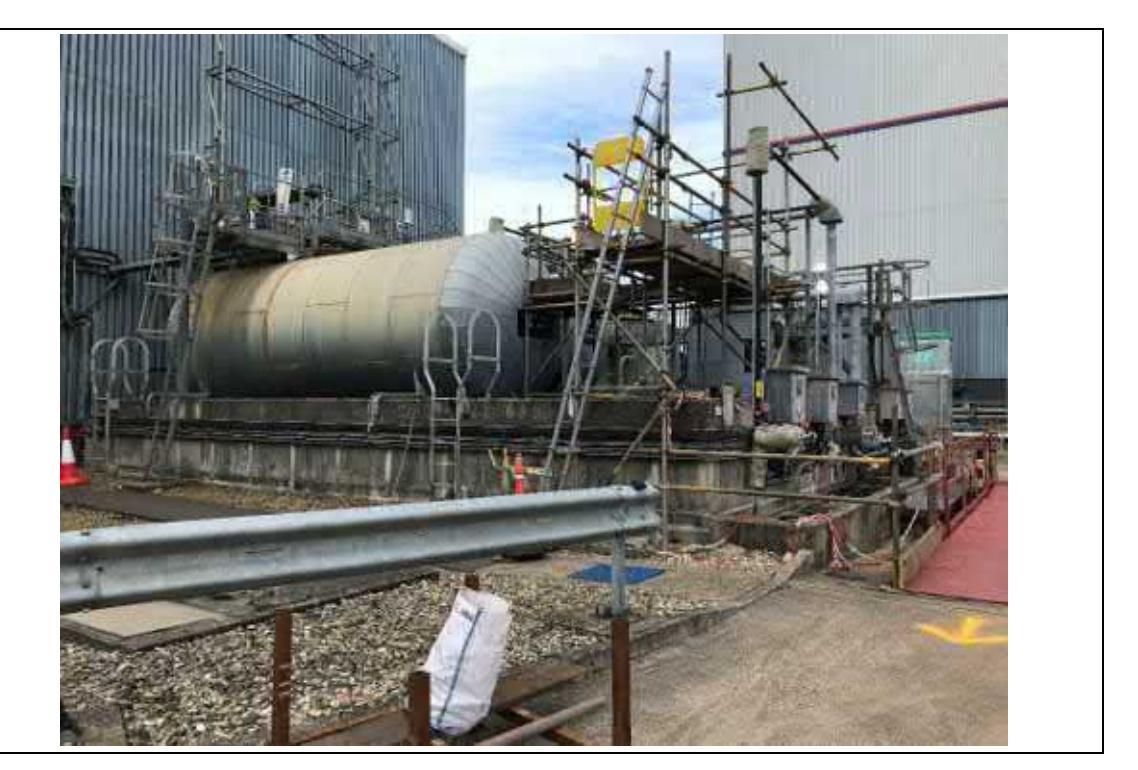
Five ASTs (above ground storage tanks) present in concrete bund adjacent to Keadby 1 Power Station site water treatment works. ASTs found to contain caustic soda, sulphuric acid and alum. Two of the ASTs were reportedly empty and previously contained sodium hypochlorite.
