SLOUGH MULTIFUEL EXTENSION PROJECT

Environmental Statement
Volume 3 – Appendix

Appendix 9A – Noise Survey Results

Application Document Reference: [6.4.7]

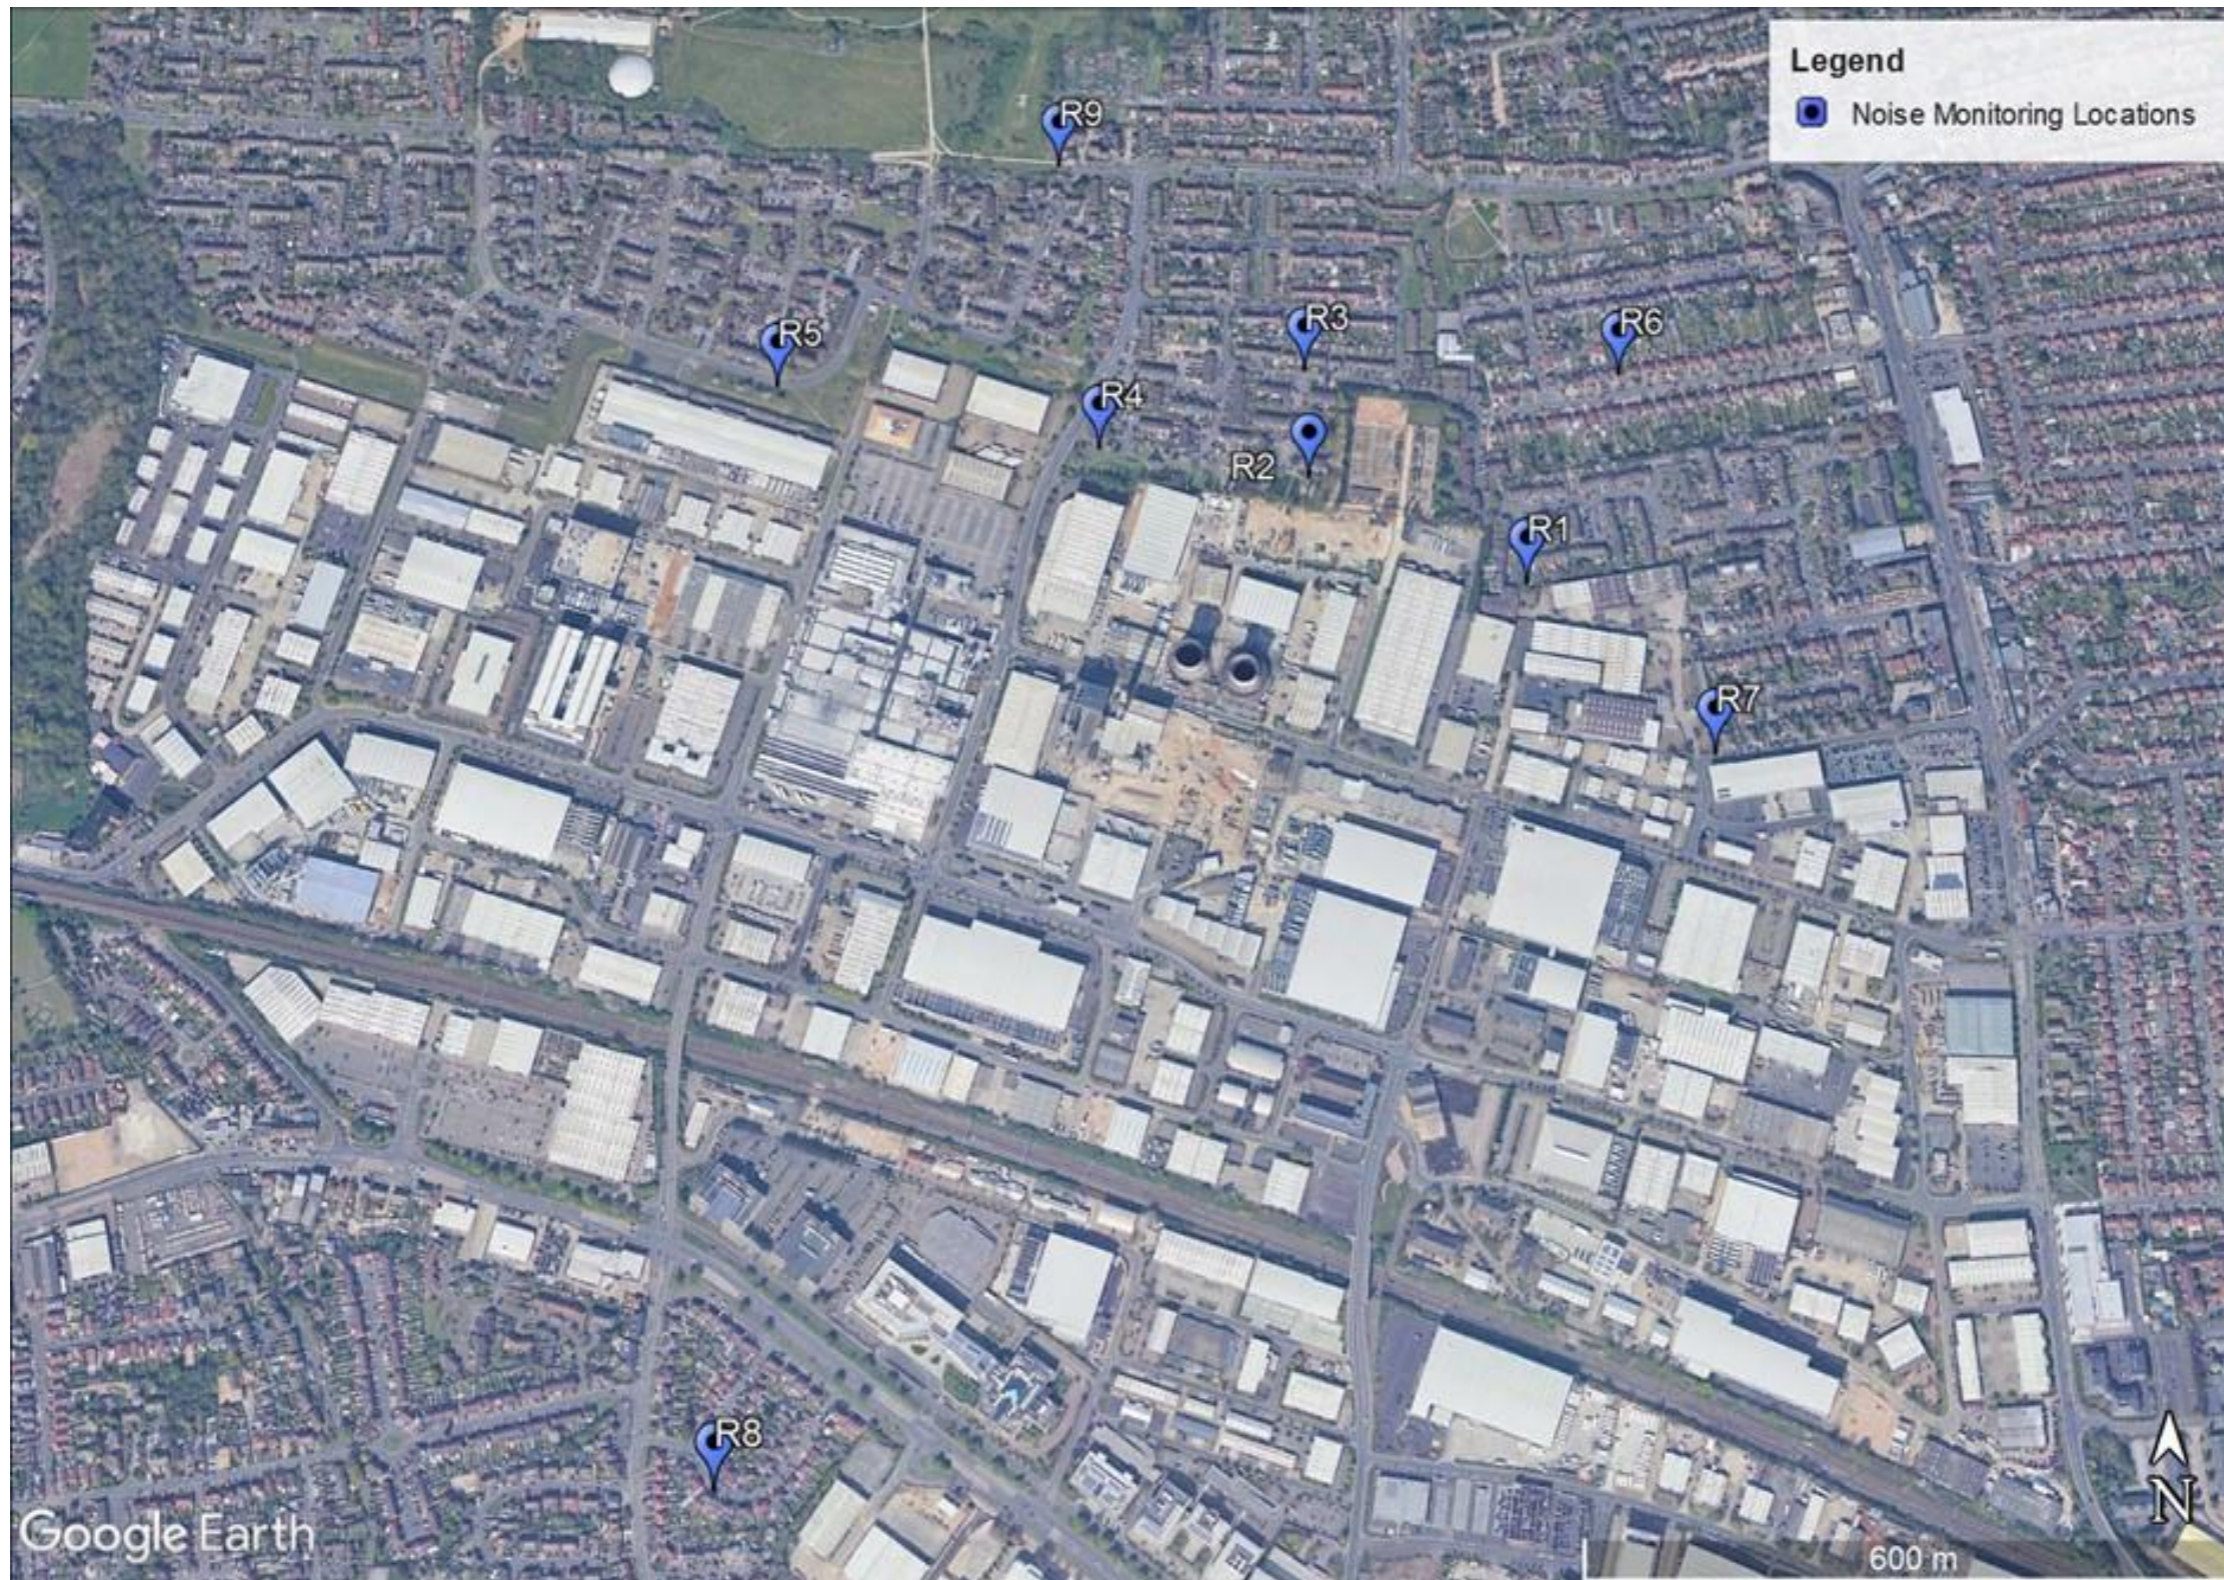
Figure 9.1 Noise Monitoring Locations

9.1.3 A map of monitoring locations in proximity to the site boundary can be found in Figure 9.1.

- R1 – Rowan Way, SL2 1EX, (51.525529 -0.621798°).
- R2 – Bodmin Avenue East, SL2 1SL, (51.526562 -0.625238°).
- R3 – Greenside, SL2 1SS, (51.527453 -0.624942°).
- R4 – Bodmin Avenue West, SL2 1SL, (51.526810 -0.628015°).
- R5 – Scaffell Road, SL2 1TZ, (51.527346 -0.632291°).
- R6 – Sandown Road, SL2 1TU, (51.527482 -0.635821°).
- R7 – Montrose Avenue, SL1 4TJ, (51.523950 -0.619333°).
- R8 – Westgate Crescent, SL1 5BY, (51.517937 -0.632850°).
- R9 – Northborough Road, SL2 1SA, (51.529423, -0.627322°).

9.1.2 Attended measurements (from 9th to 10th February 2022) were undertaken at nine locations that are representative of sensitive receptors that may be adversely affected by noise generated by the Proposed Project. All measurements were undertaken under free-field conditions with the microphone located at least 3m from a reflective surface (other than the ground). All noise measurements include the following parameters: L_{Aeq} , L_{A90} , L_{A10} and L_{AFmax} over contiguous 15-minute samples. Field calibrators were applied to each instrument at the start and end of each measurement and no significant calibration drift was detected (± 0.5 dB).
